TECHNICAL BULLETIN

TAP148

NISSAN PATROL GQ/GU RADIUS ARM TO CHASSIS RUBBER BUSHINGS

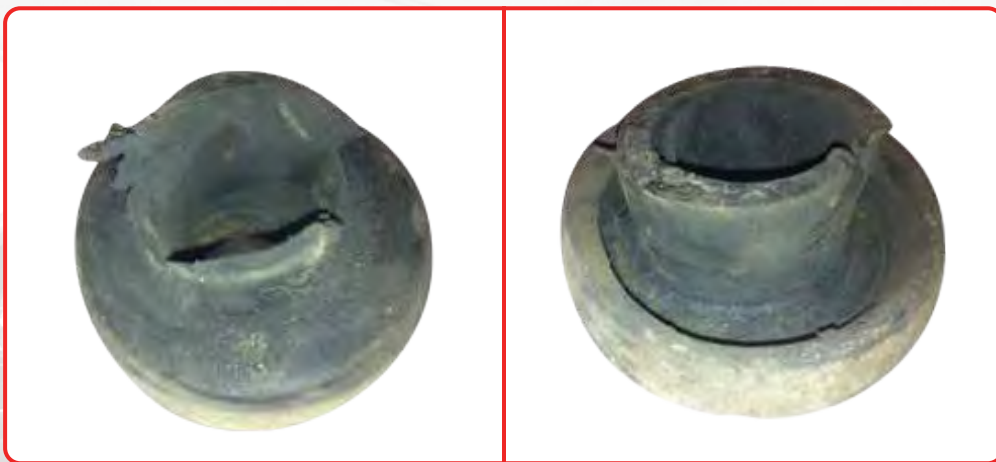
If your Patrol Radius Arm to Chassis Bushings are showing wear characteristics as illustrated in the pics opposite, it could be due to a number of reasons.

- 1.** The Durometer of the rubber replacement bushing is too soft - rectified by fitting Roadsafe rubber bushings S0500R in 65 duro
- 2.** If the vehicle has over 2" lift the angle of the radius arm will promote excessive pre-load and premature wear of the bushings - rectified by fitting Blackhawk 4X4 Patrol radius arms (RANPBV2).
